FINAL REPORT
SRB SEAWATER CORROSION PROJECT
July, 1991
(NAS8-38800)

Auburn University, Solid State Sciences Center,
Department of Physics

M. J. Bozack

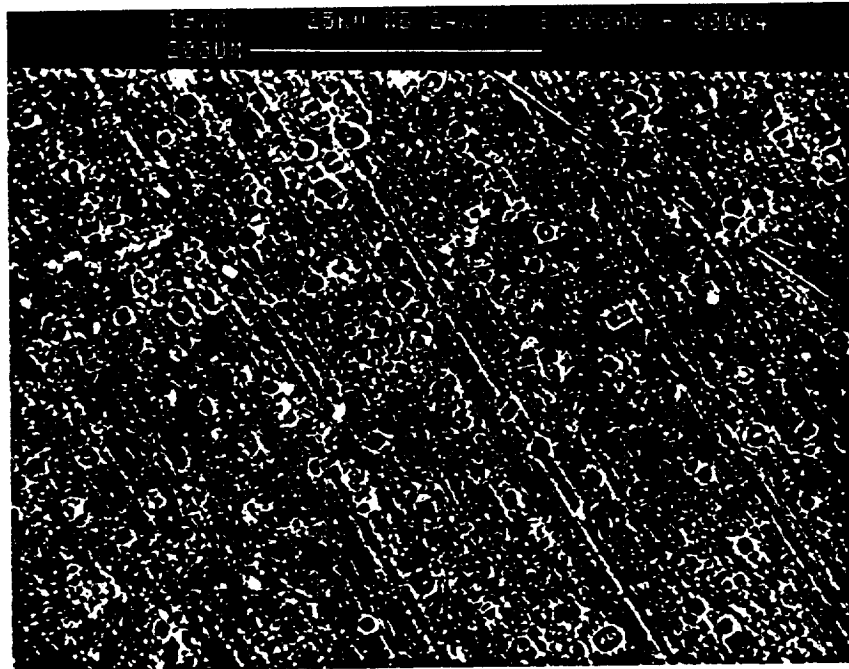
Fig. 2. SEM micrograph of as received 2219 aluminum used in SRB construction. The surface is uniformly pitted.

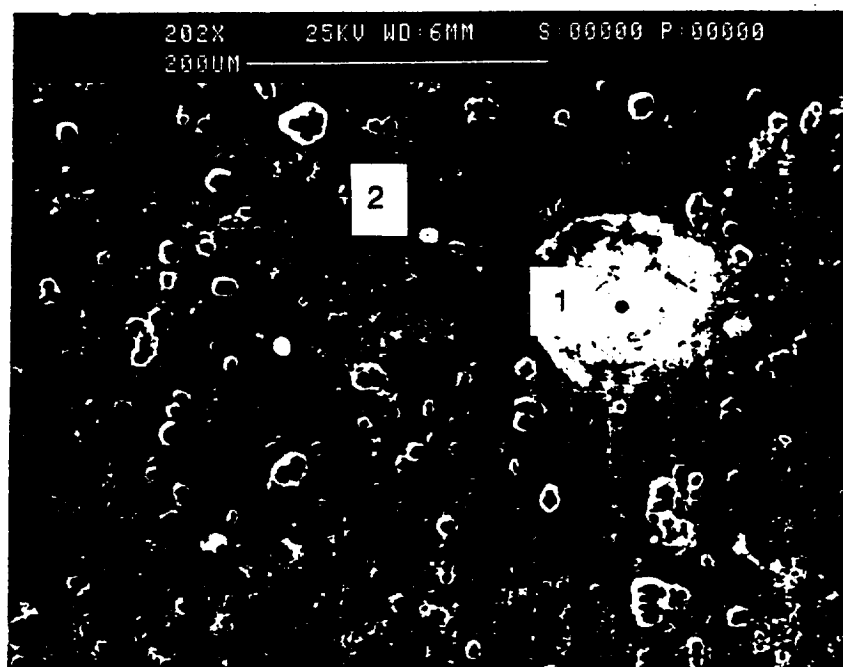
Fig. 8. High magnification (a) optical and (b) SEM views of the $T = 30\text{ C}$ corrosion products.

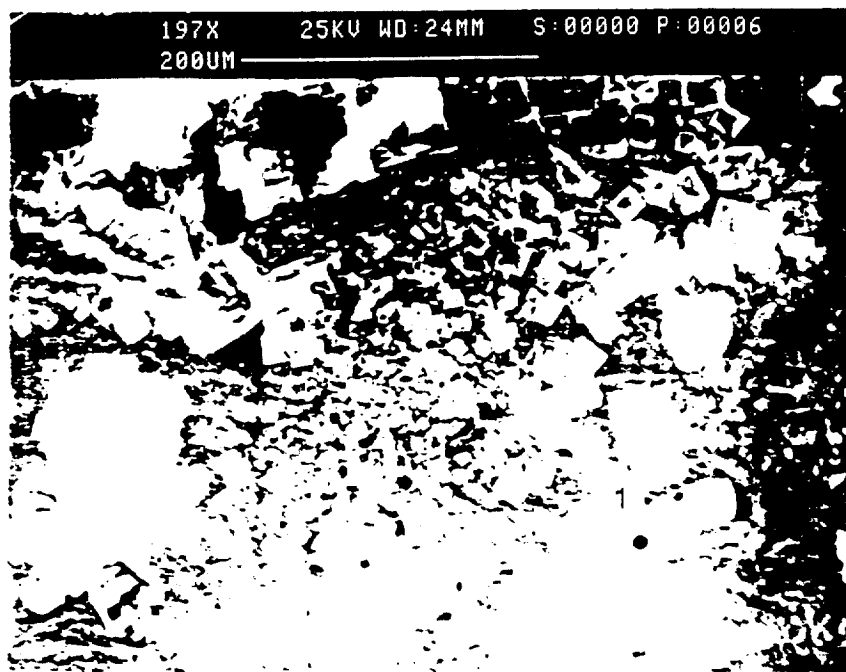
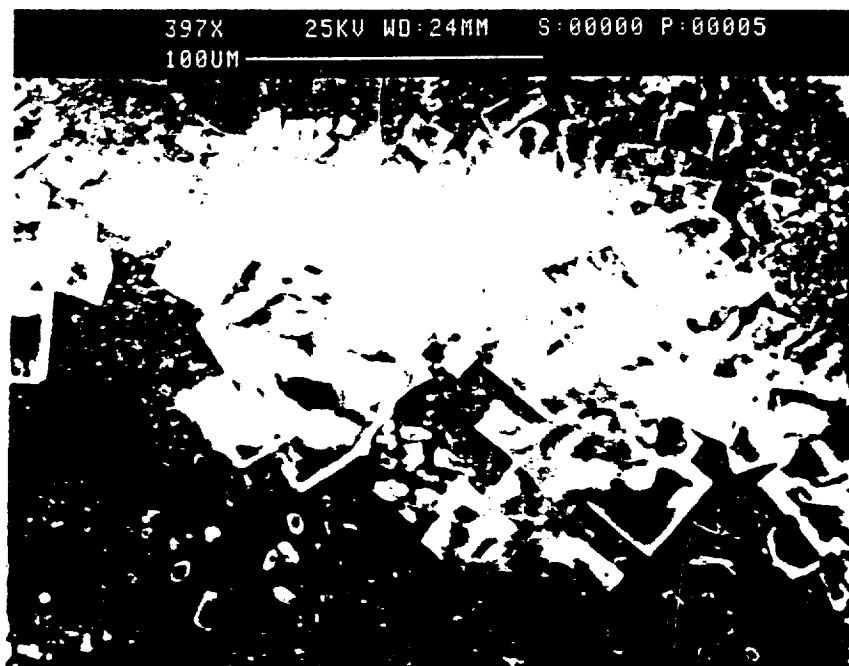
Fig. 14. High magnification SEM views of the $T = 60\text{ C}$ corrosion products, in a region where extensive growth of cubic crystals occurred.

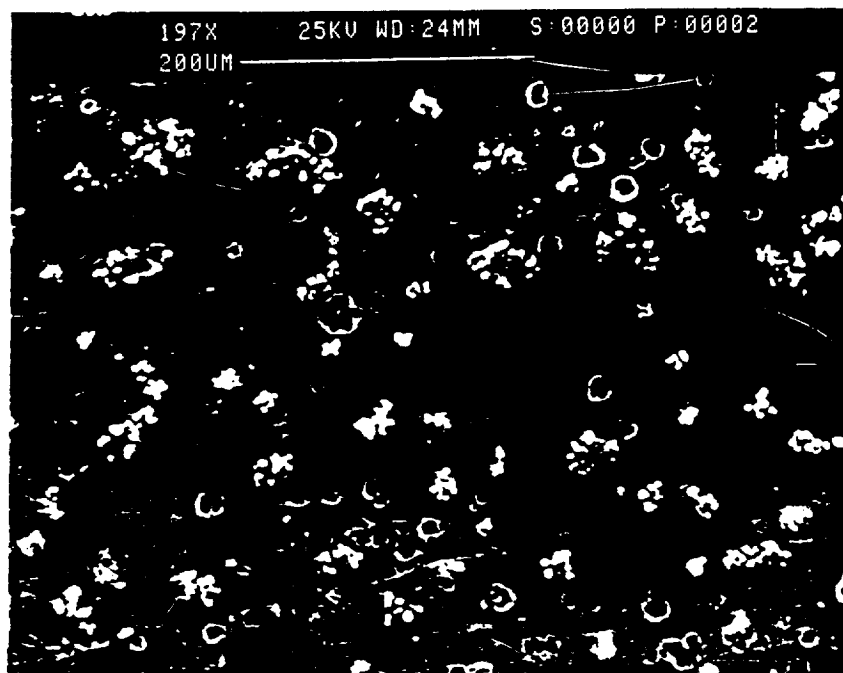
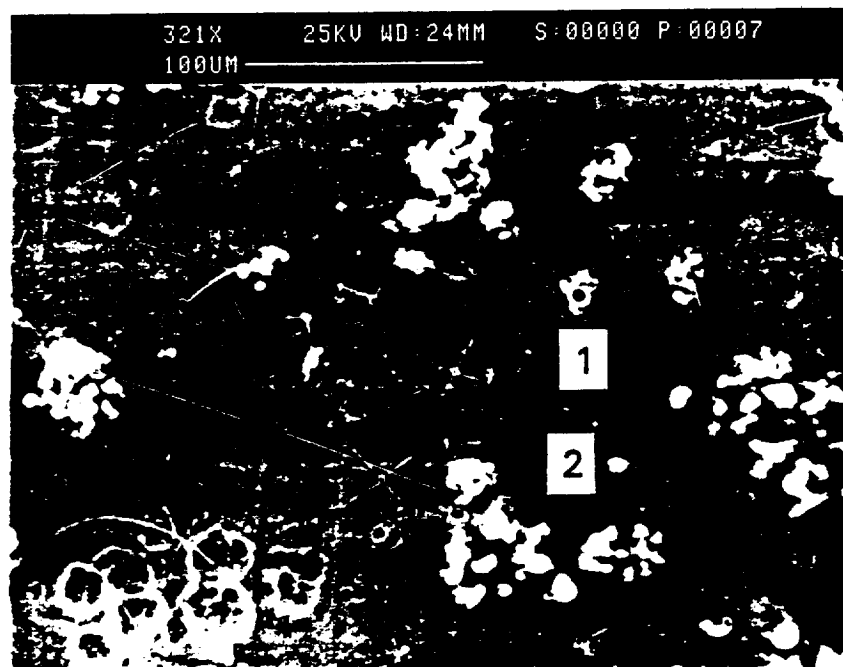
Fig. 16. High magnification SEM views of the $T = 60\text{ C}$ corrosion products, in a region where small, localized moundlike structures are observed. The growth of small cubic crystals is also observed, with four dendrites extending from each corner.

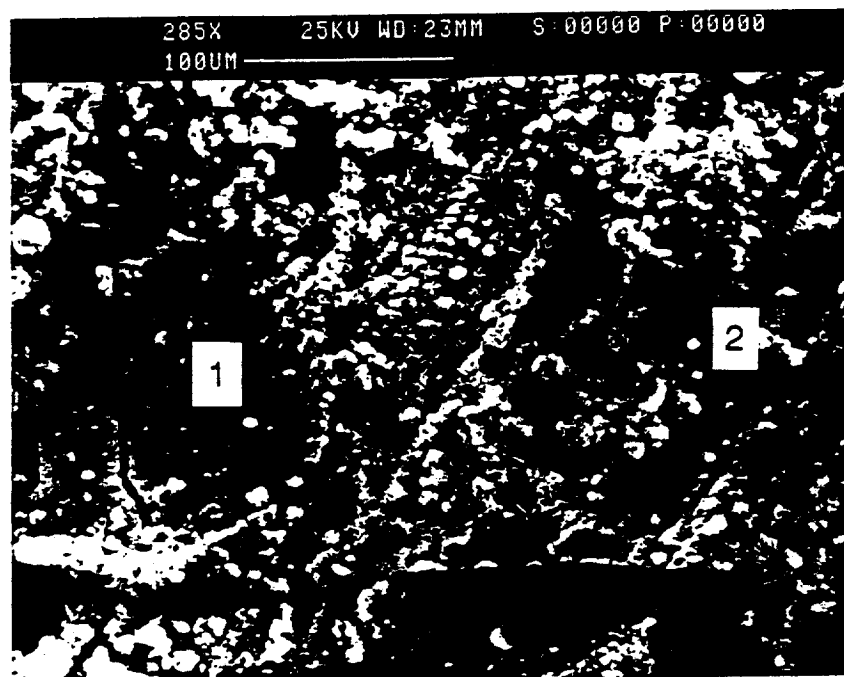
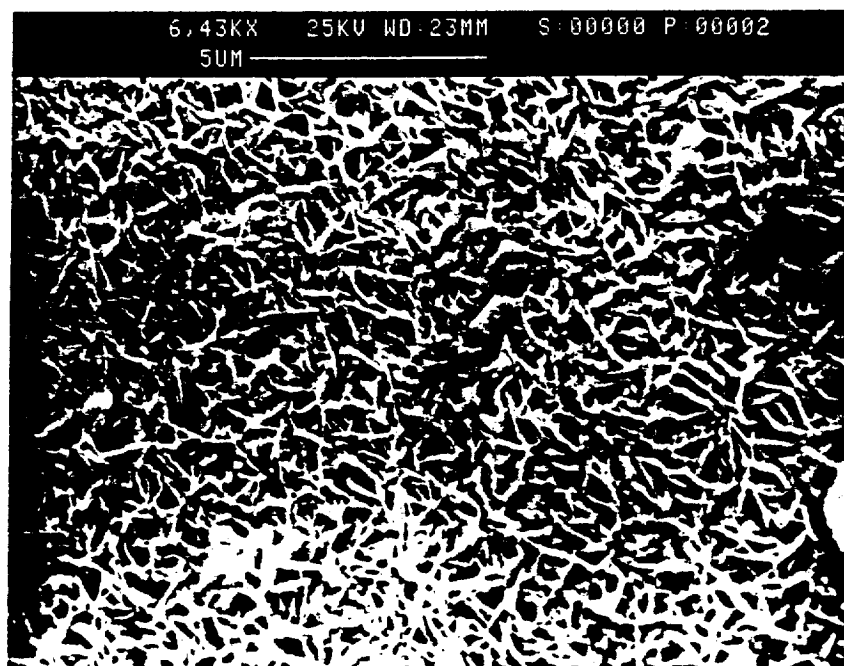
Fig. 21. High magnification SEM views of the $T = 100\text{ C}$ corrosion products in a region where extensive crystal growth occurred. The view in (b) is a blowup of the region at position 1 in photo (a). The corrosion products are different in appearance (cf. Fig. 16) from the corrosion products observed at $T = 60\text{ C}$.

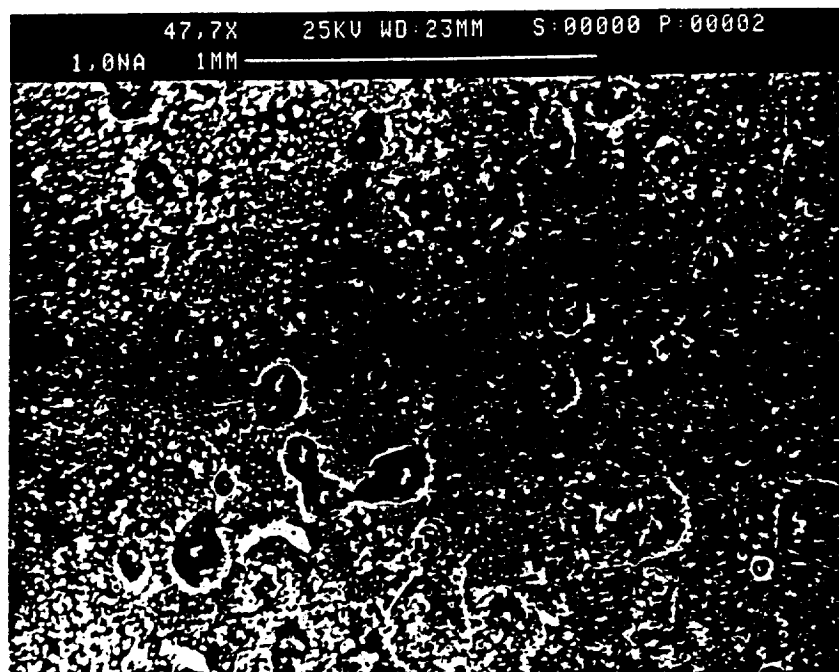
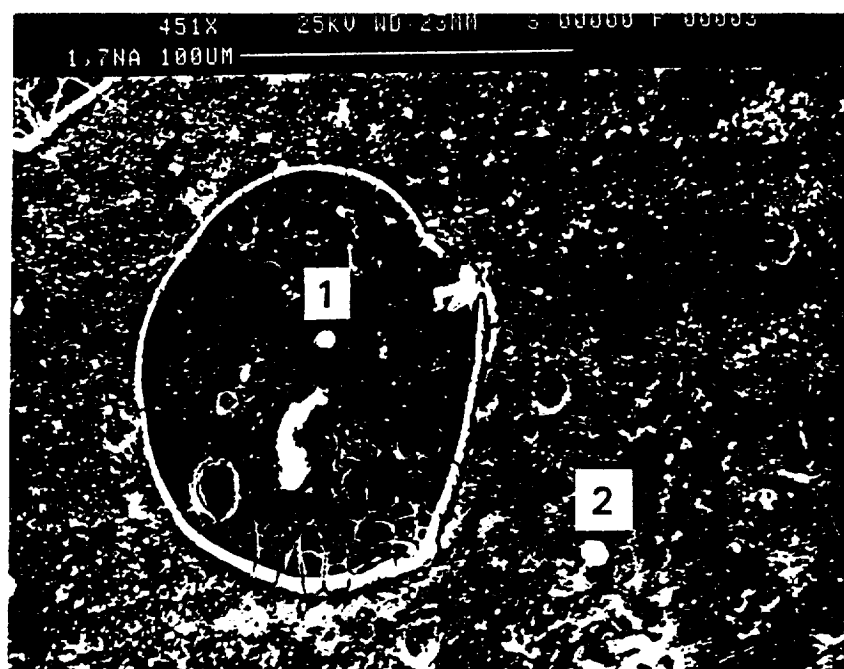
Fig. 26. SEM photographs of the $T = 30\text{ }^{\circ}\text{C}$ salt solution exposed 2219 aluminum surface. The view in (b) is a blowup of one of the features in (a). Cf. Figs. 7 and 8 to compare corrosion products in seawater at $T = 30\text{ }^{\circ}\text{C}$.

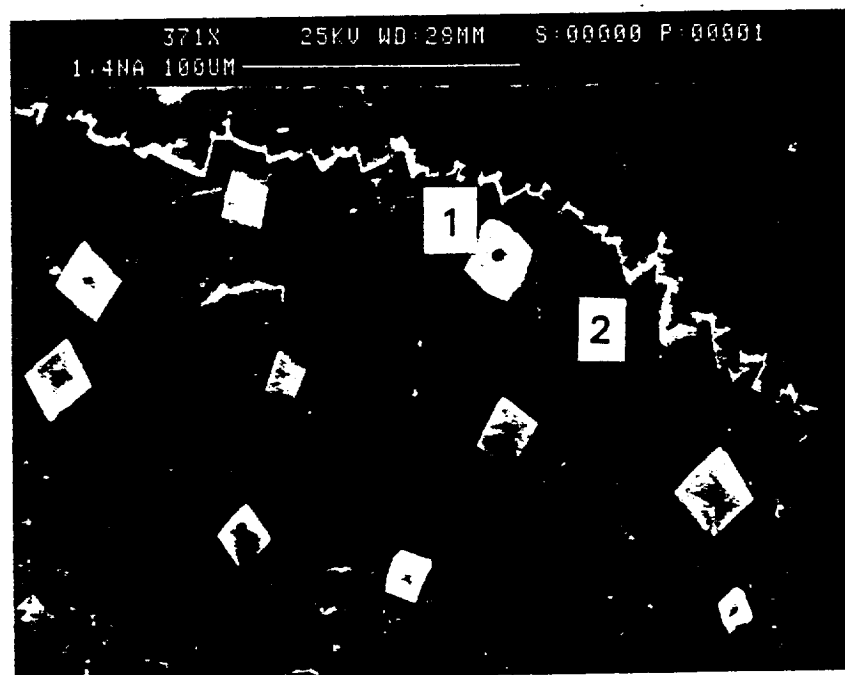
Fig. 34. Optical and SEM micrographs of 2219 aluminum (frontside) after 2.0 hours of 3.5% salt solution exposure at $T = 100\text{ C}$. The optical photograph looks the same before and after the exposure. No corrosion is observed. The SEM photo shows NaCl crystals scattered over the surface.
